Loaded Board Assembly with 0201 placements

Inspection Capability Analysis of the Testronics Model 505 AOI System

6 assemblies were presented to Testronics for 0201 & fine pitch evaluation. One reference assembly (golden board) + 5 assemblies with known defects. Top and bottom were to be evaluated.

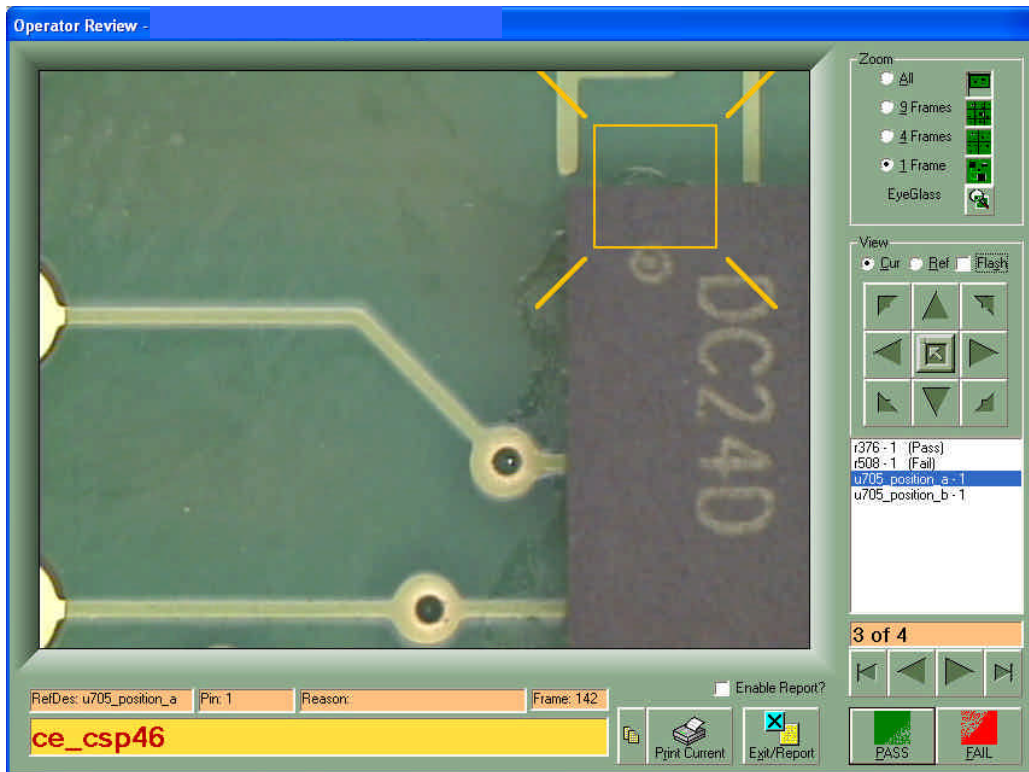
S/N# 1_Top:

U705 position / shift (BGA)

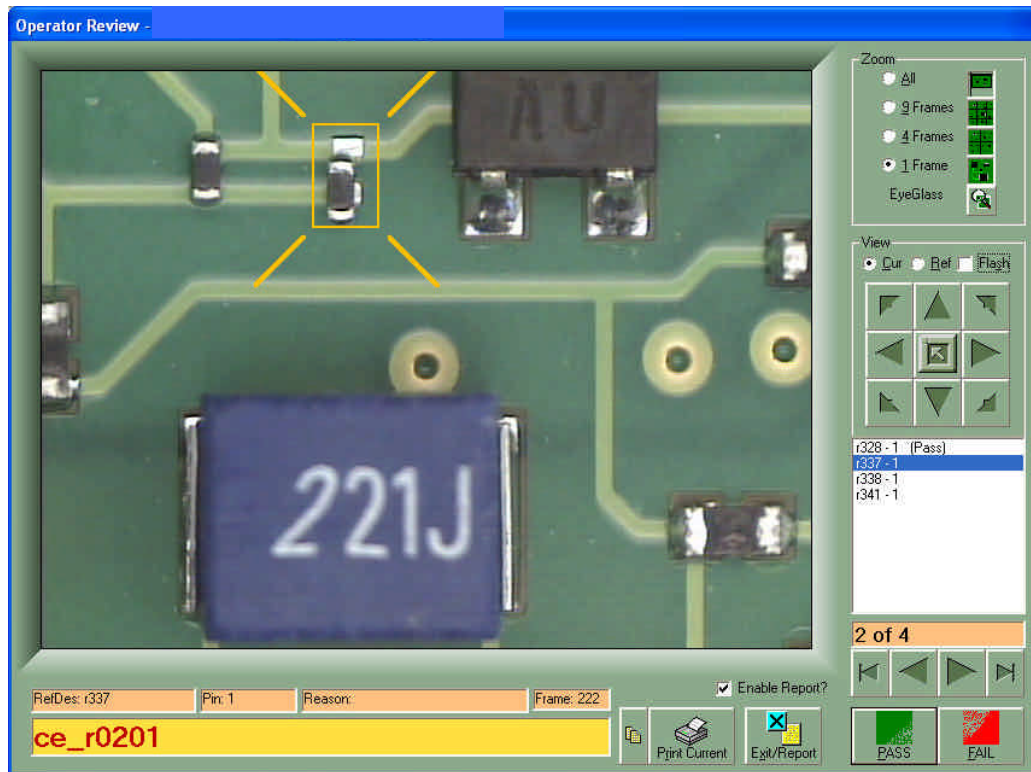
S/N# 2_Top:

R337 position / shift (0201)

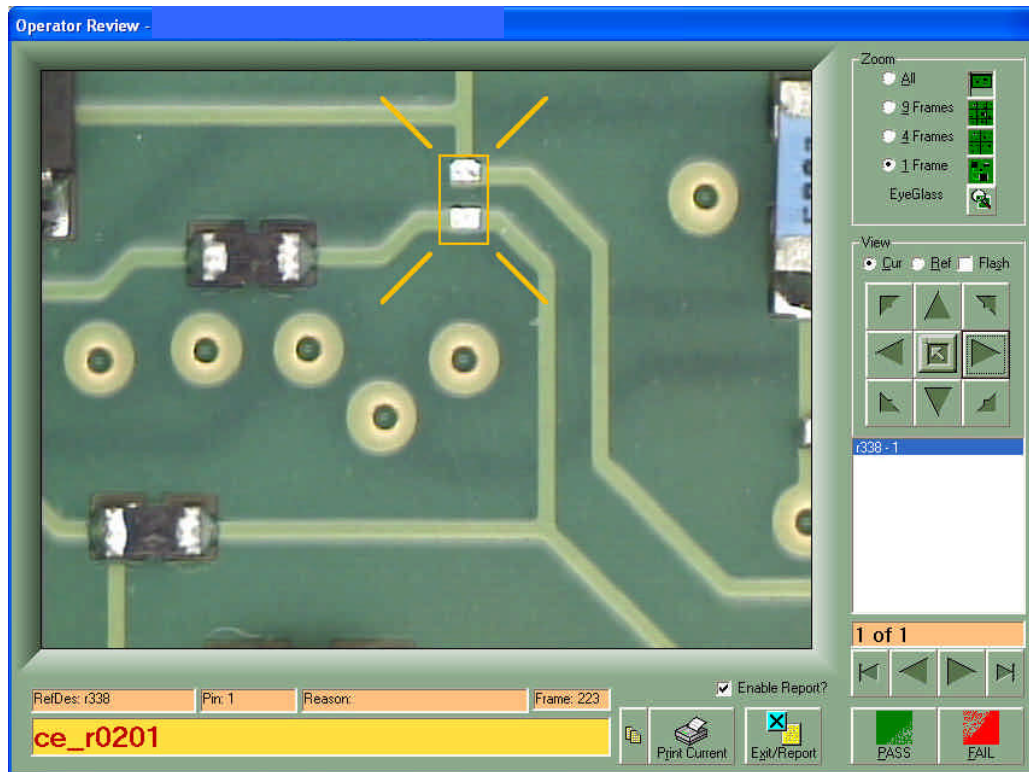
S/N# 2_Top:

R338 missing (0201)

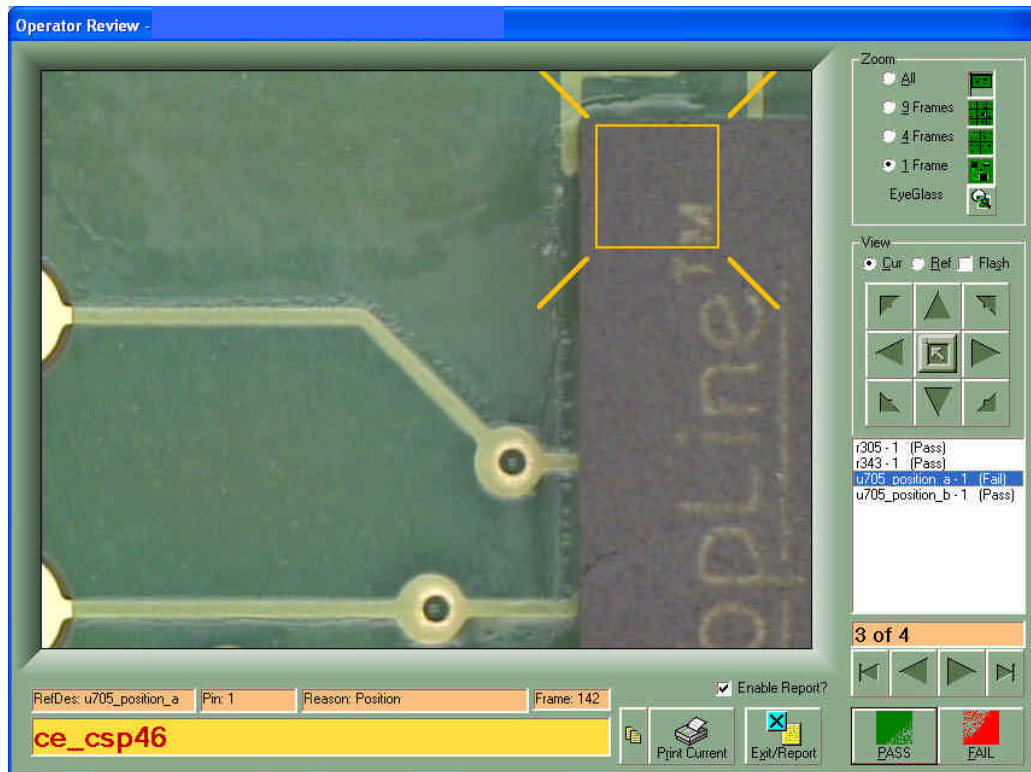
S/N# 3_Top:

U705 reversed (BGA)

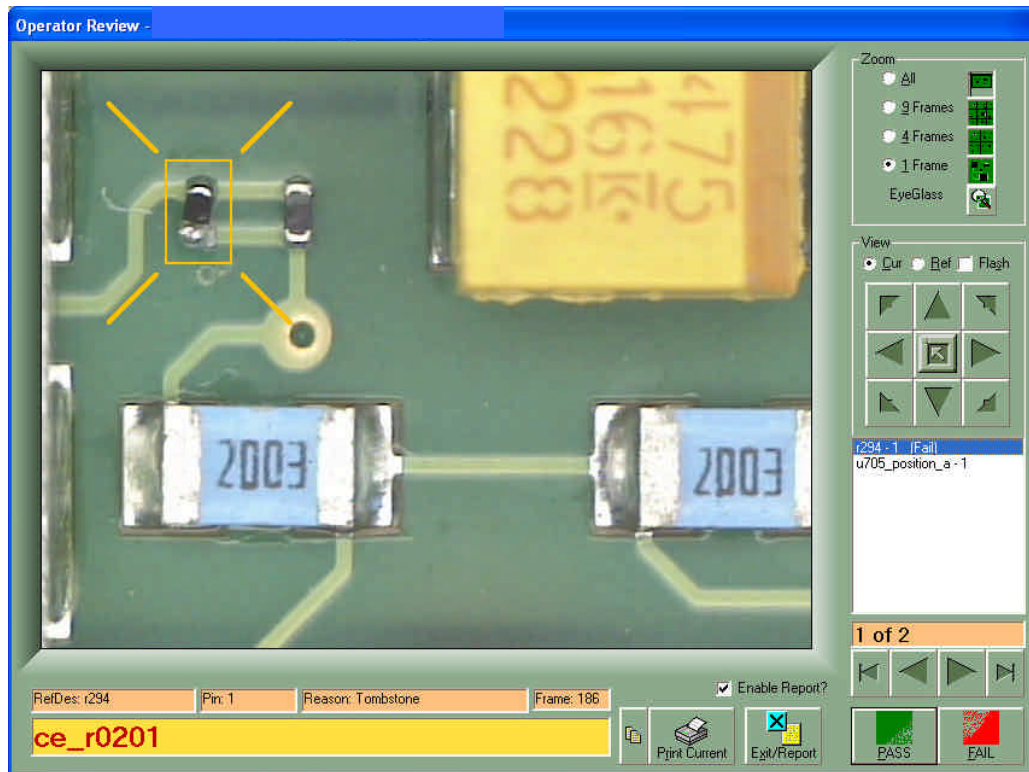
S/N# 3_Top:

R294 tombstone (0201)

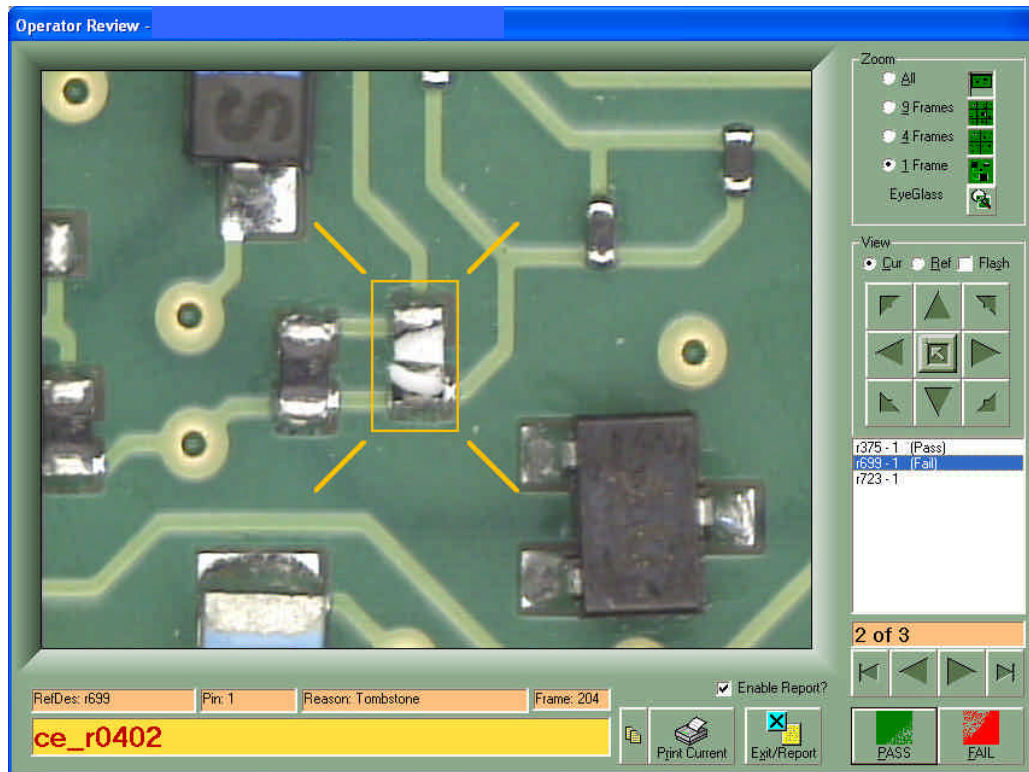
S/N# 5_Top:

R669 damaged (0402)

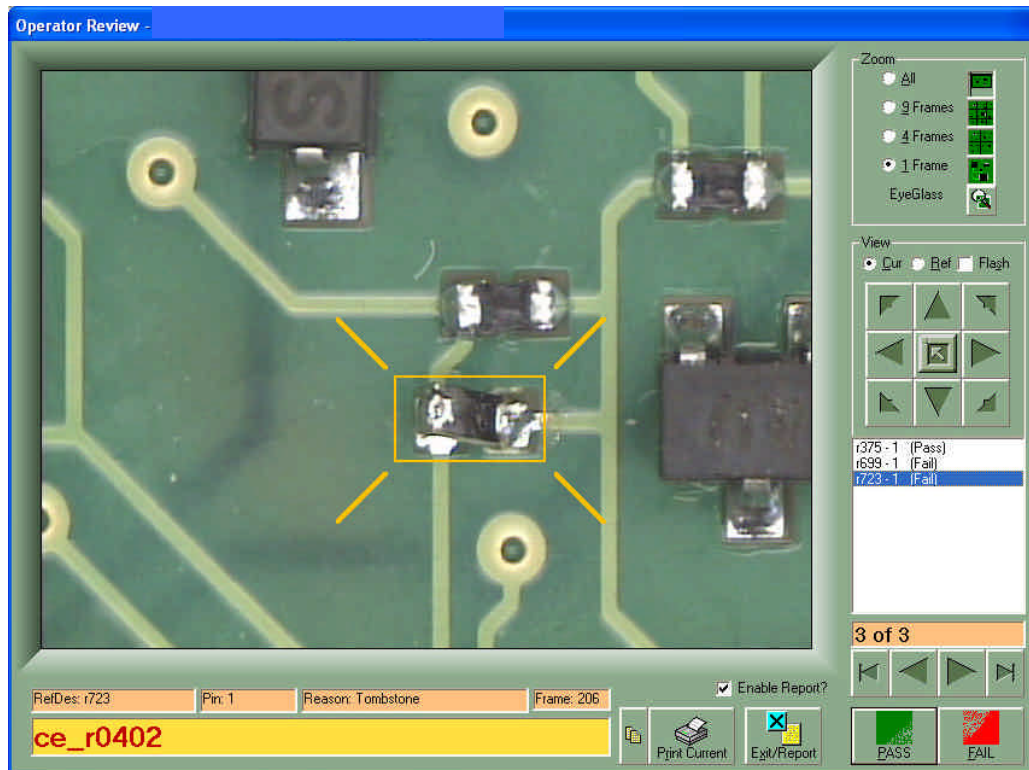
S/N# 5_Top:

R723 tombstone (0402)

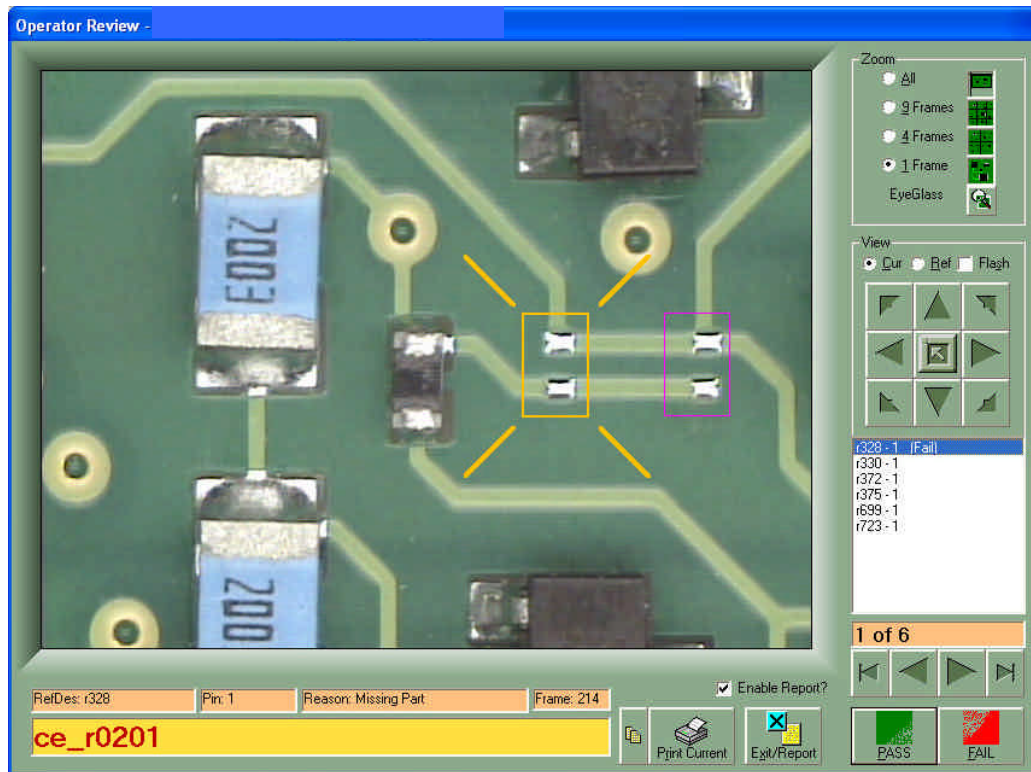
S/N# 5_Top:

R328 missing (0201)

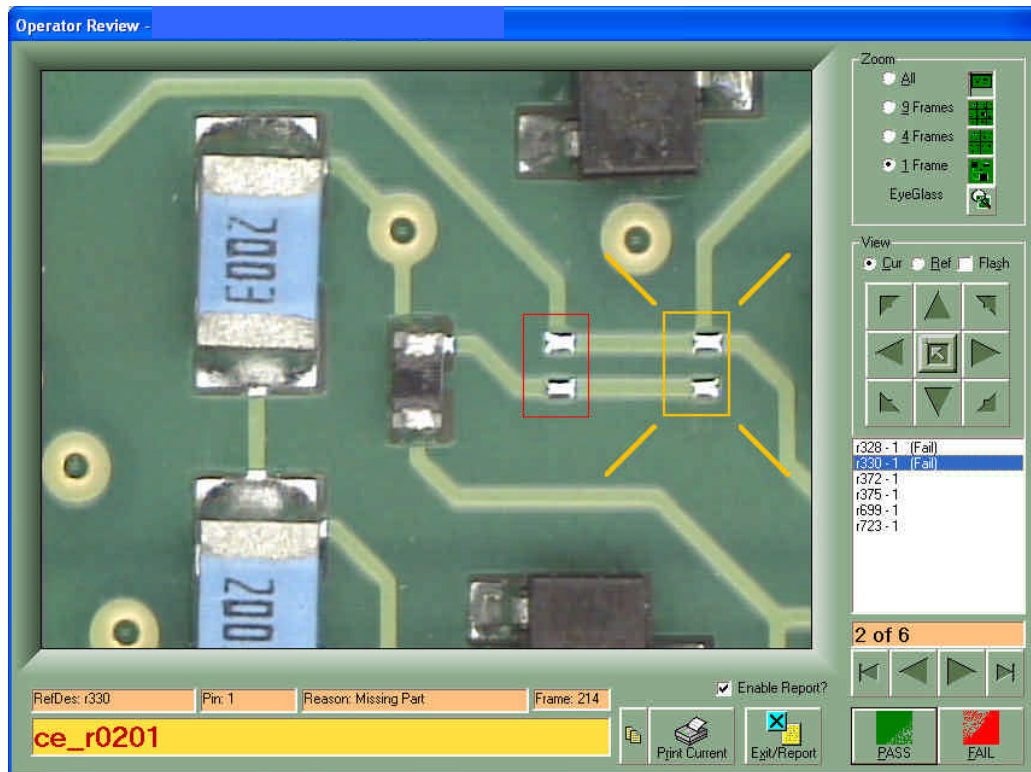
S/N# 5_Top:

R330 missing (0201)

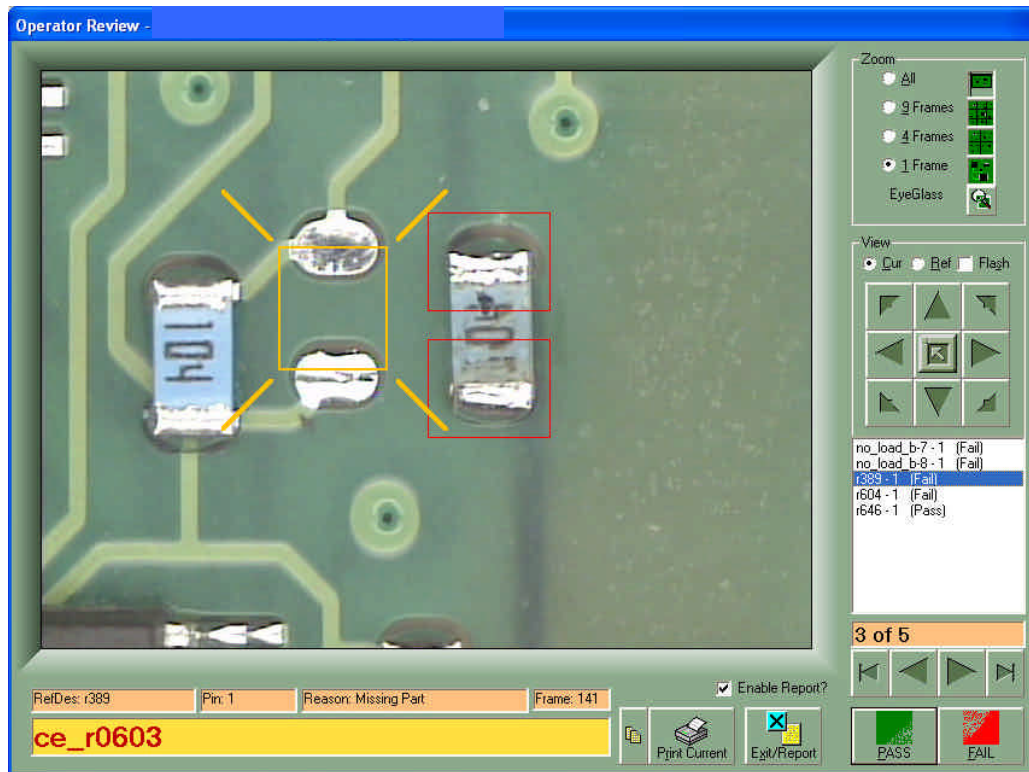
S/N# 1_Bottom:

R389 missing (0603)

Component in no-load position

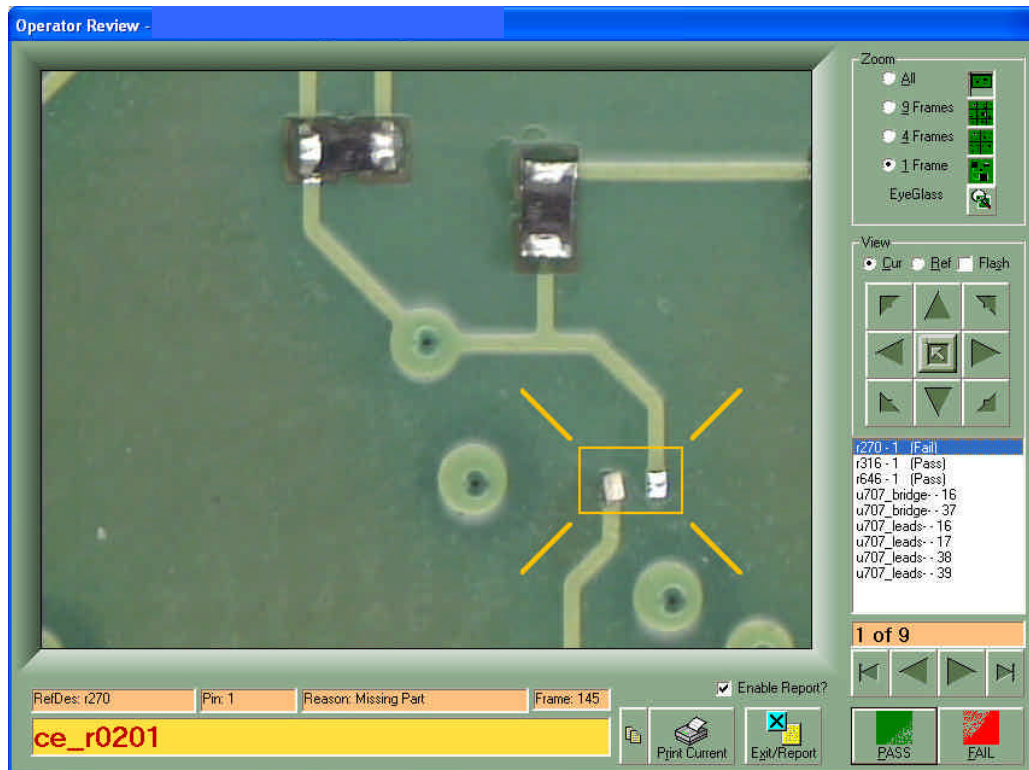
S/N# 2_Bottom:
R270 Missing (0201)

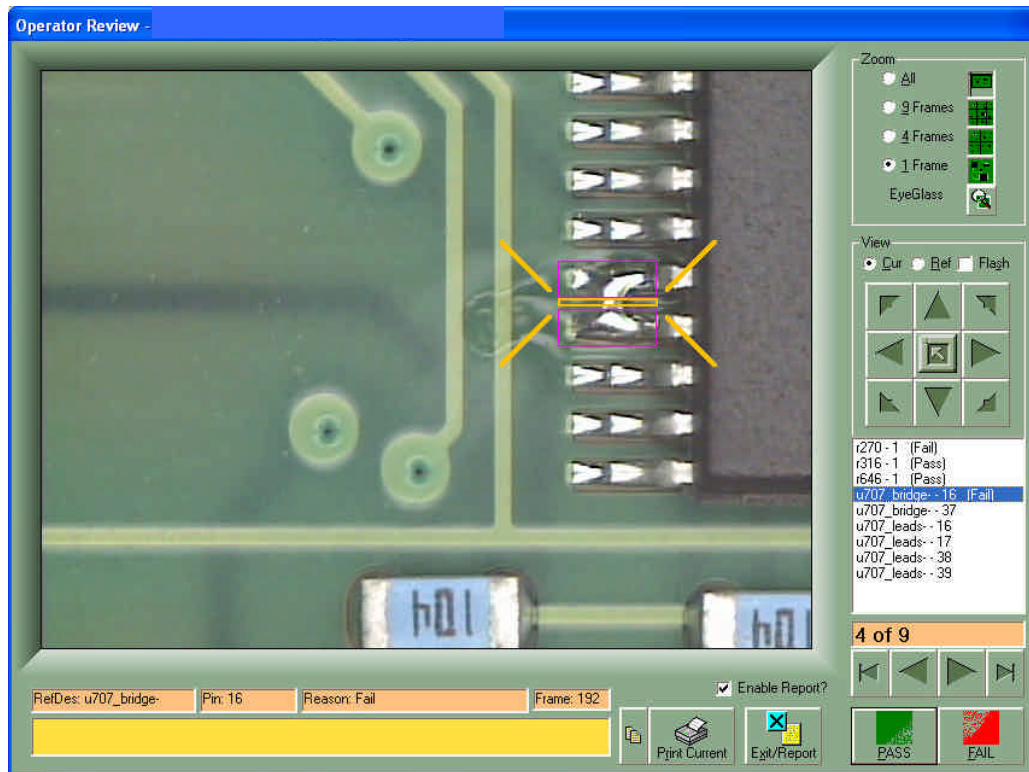
S/N# 2_Bottom:

U707 bridge pins 16 & 17

(20 mil" package)

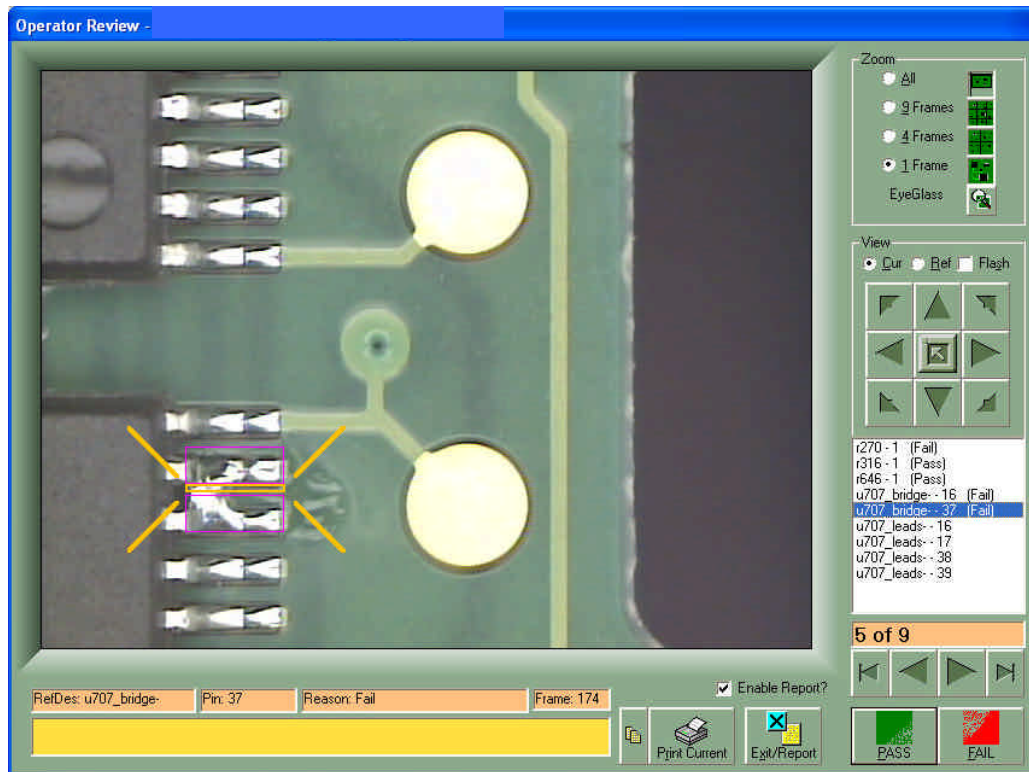
S/N# 2_Bottom:

U707 bridge pins 38 & 39

(20 mil" package)

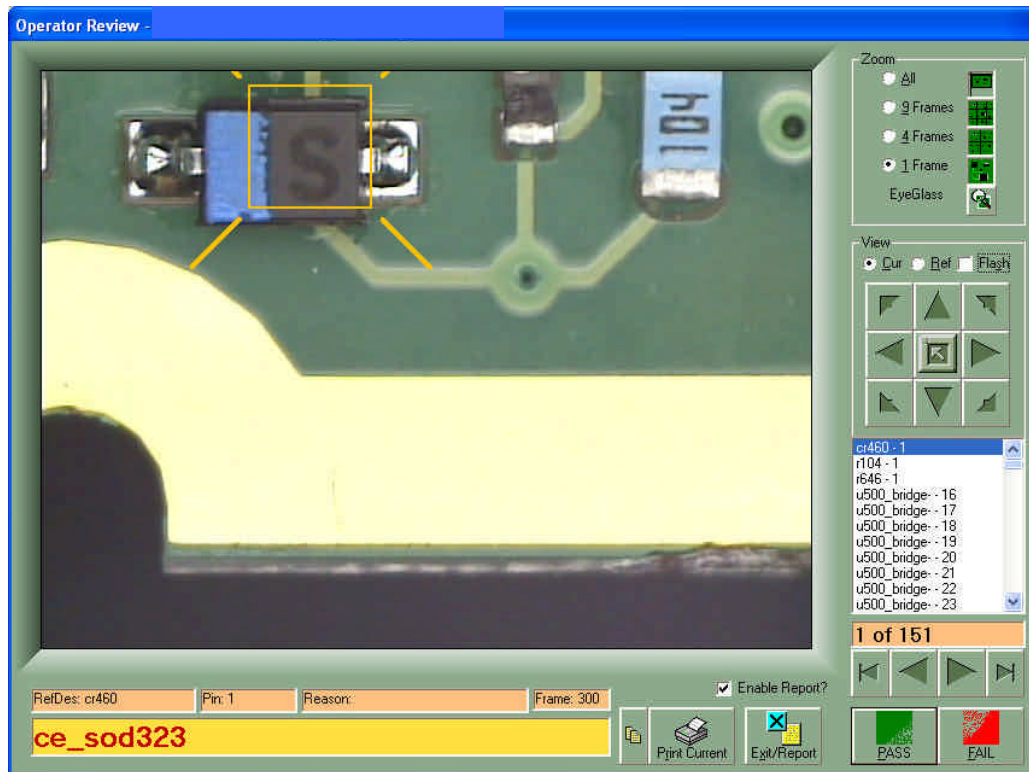
S/N# 4_Bottom:
CR460 reversed

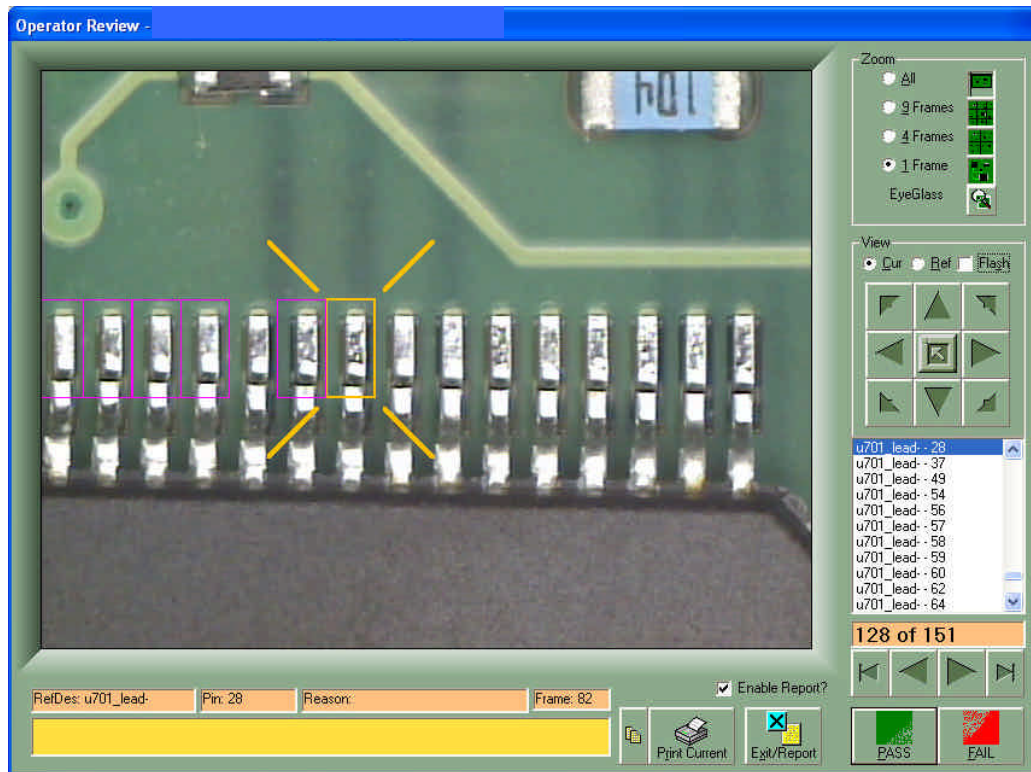
S/N# 4_Bottom:

U701 skewed

(20 mil" package)

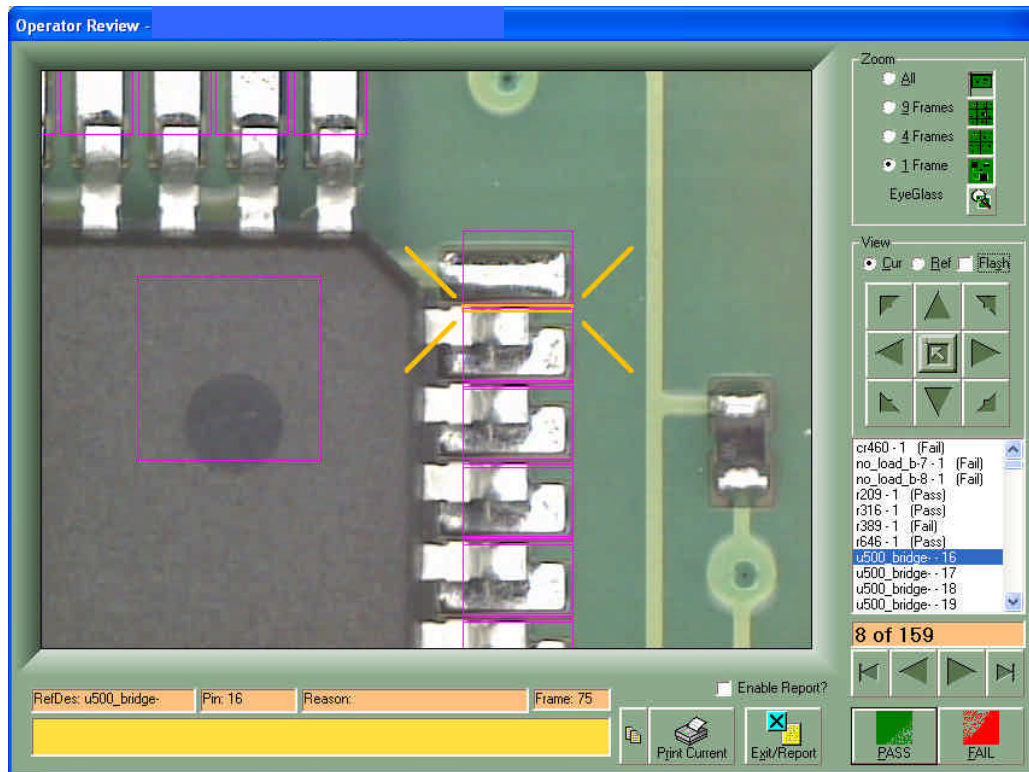
S/N# 5_Bottom:

U500 shifted

(32 mil" package)

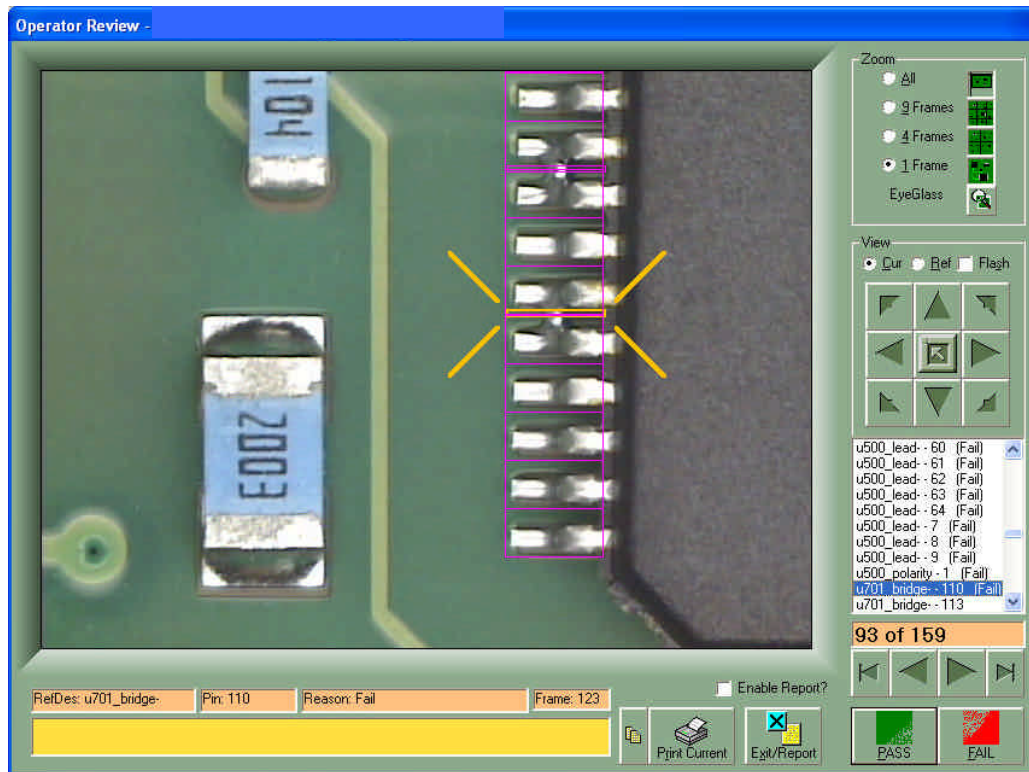
S/N# 5_Bottom:

U701 bridge pins 113 & 114

(20 mil" package)

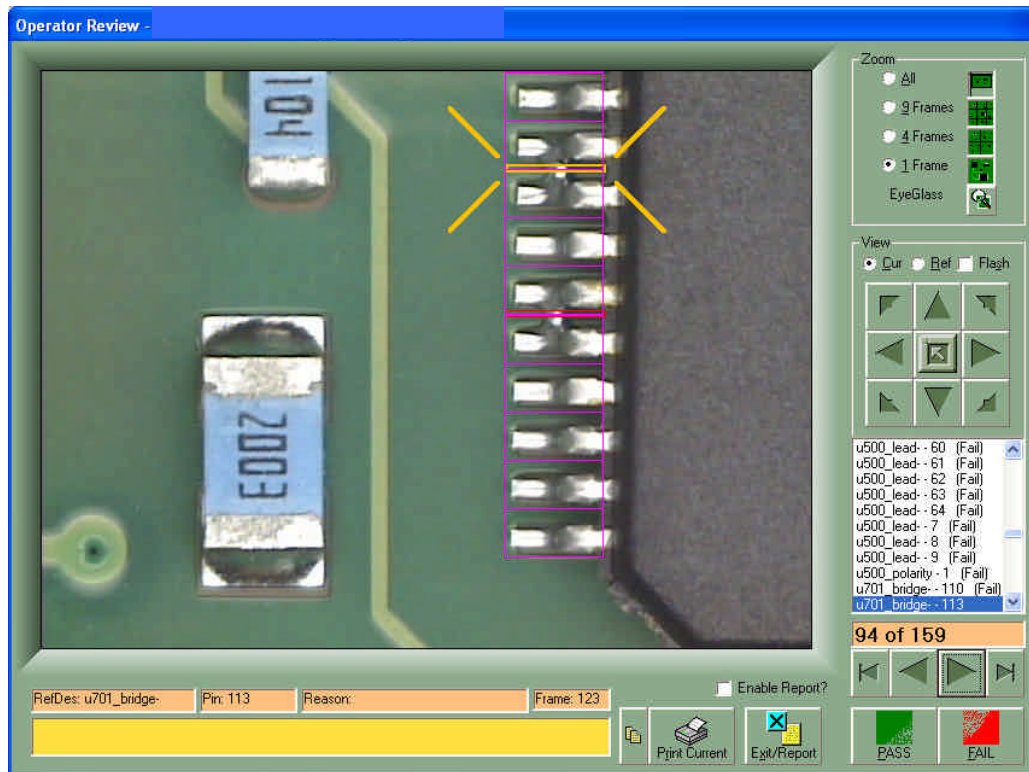
S/N# 5_Bottom:

U701 bridge pins 116 & 117

U701 skewed

(20 mil" package)
